BORING NUMBER BH-01

CLIENT SPIA - SOCIEDAD PUERTO INDUSTRIAL AGUADULCE

PROJECT NAME PUERTO AGUADULCE

GEO TECH BH PLOTS GEOTECHNICAL INVESTIGATION FOR SPIA. TEST BORINGS LOGS.GPJ GINT STD CANADA LAB.GDT 5/7/13

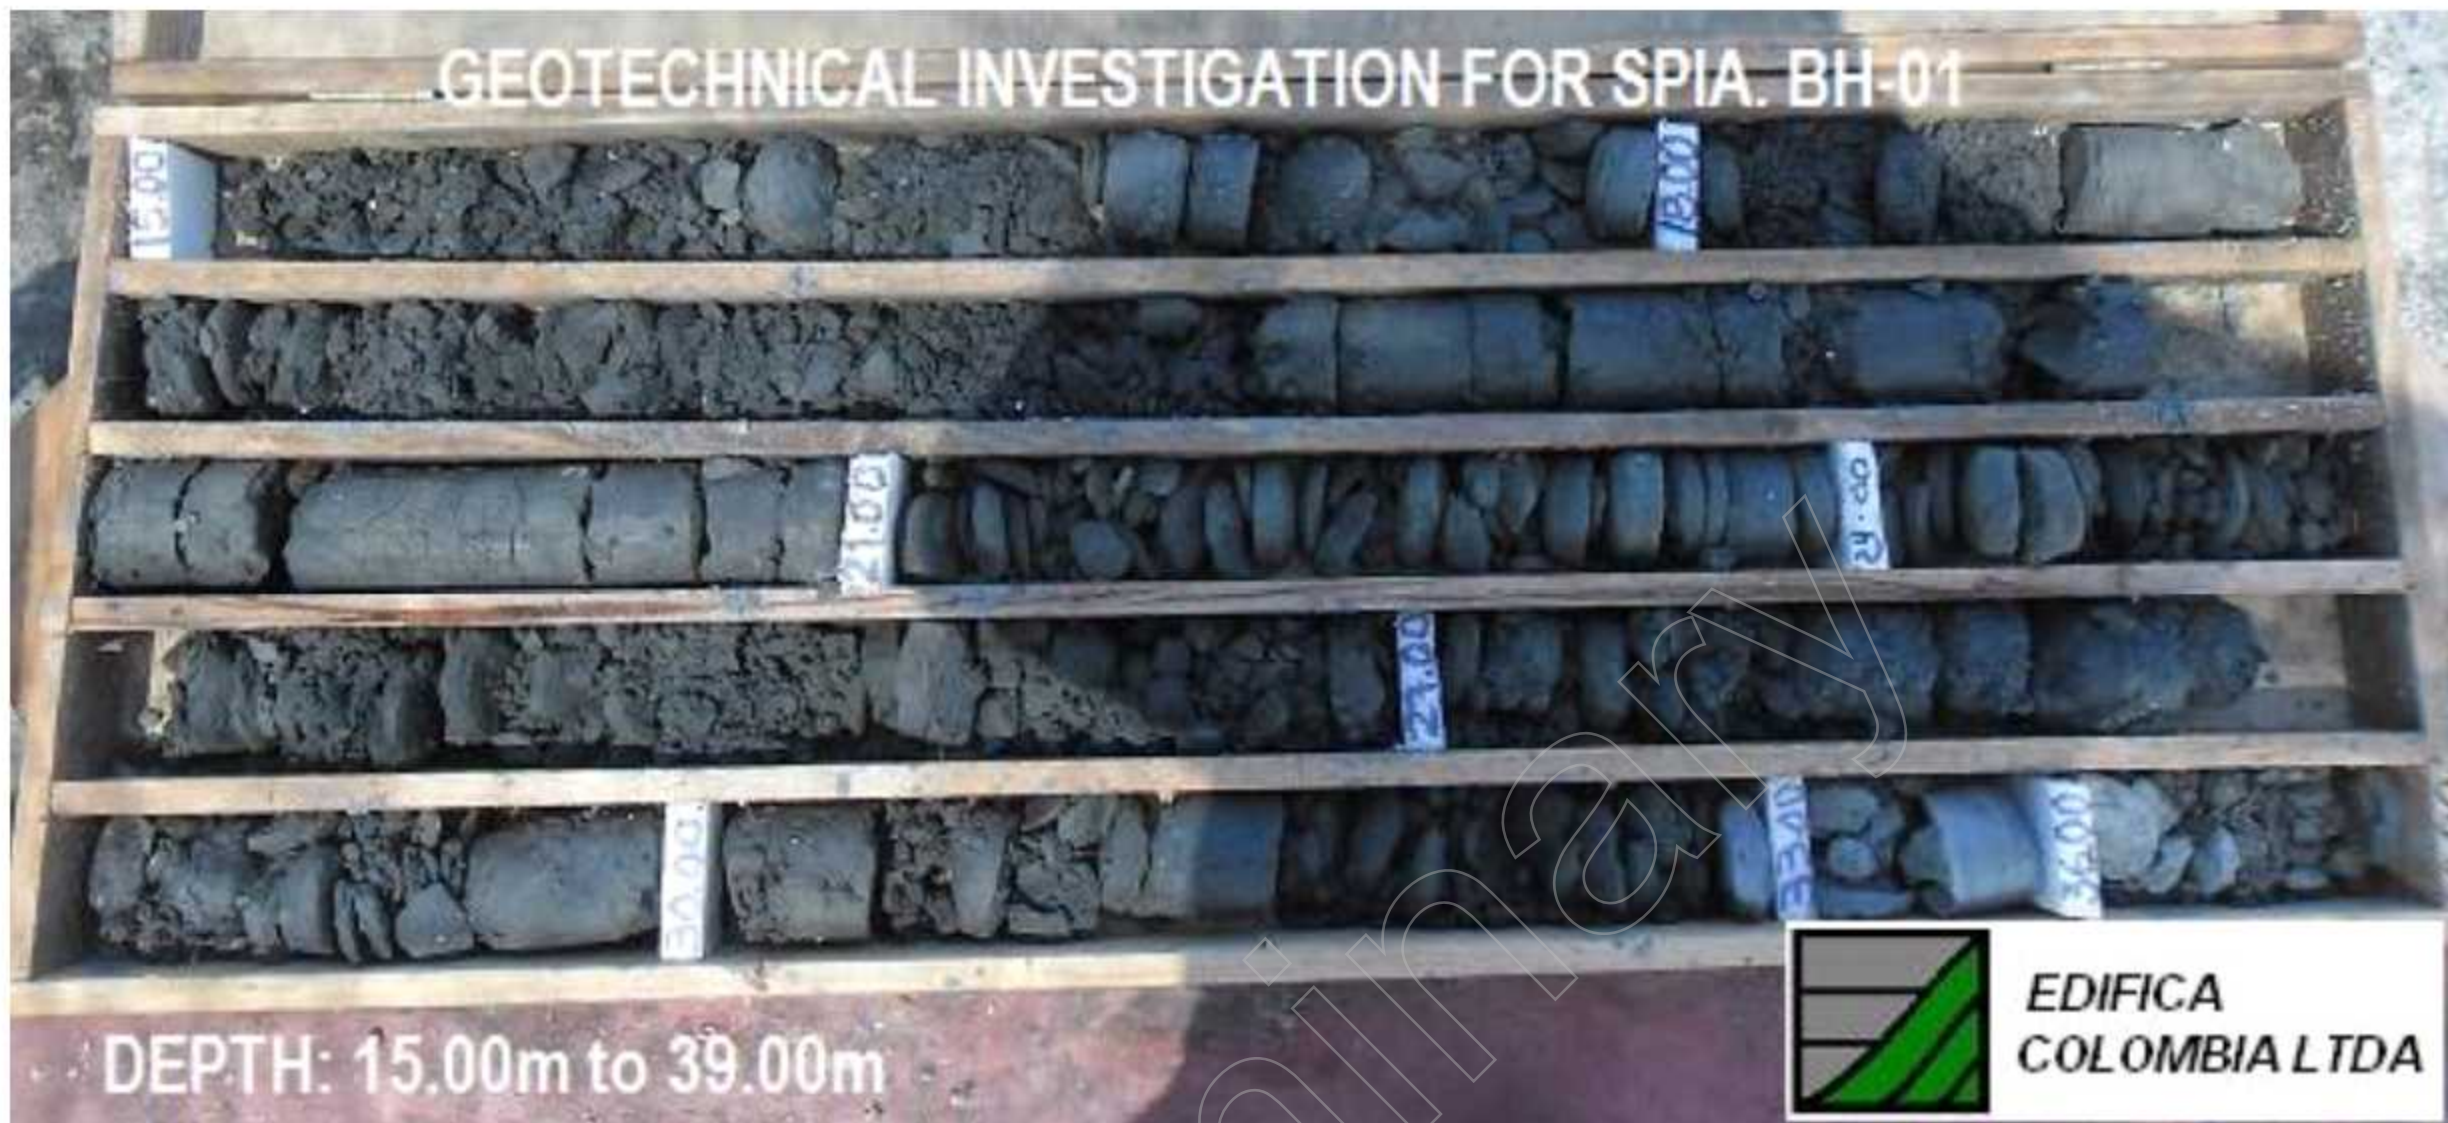
GEOTECHNICAL INVESTIGATION FOR SPIA.
BOREHOLE BH-01

PHOTOGRAPHIC RECORD ROCK CORES
