BORING NUMBER BH-03

PROJECT NAME PUERTO AGUADULCE

GEOTECHNICAL INVESTIGATION FOR SPIA.
BOREHOLE BH-03

PHOTOGRAPHIC RECORD ROCK CORES

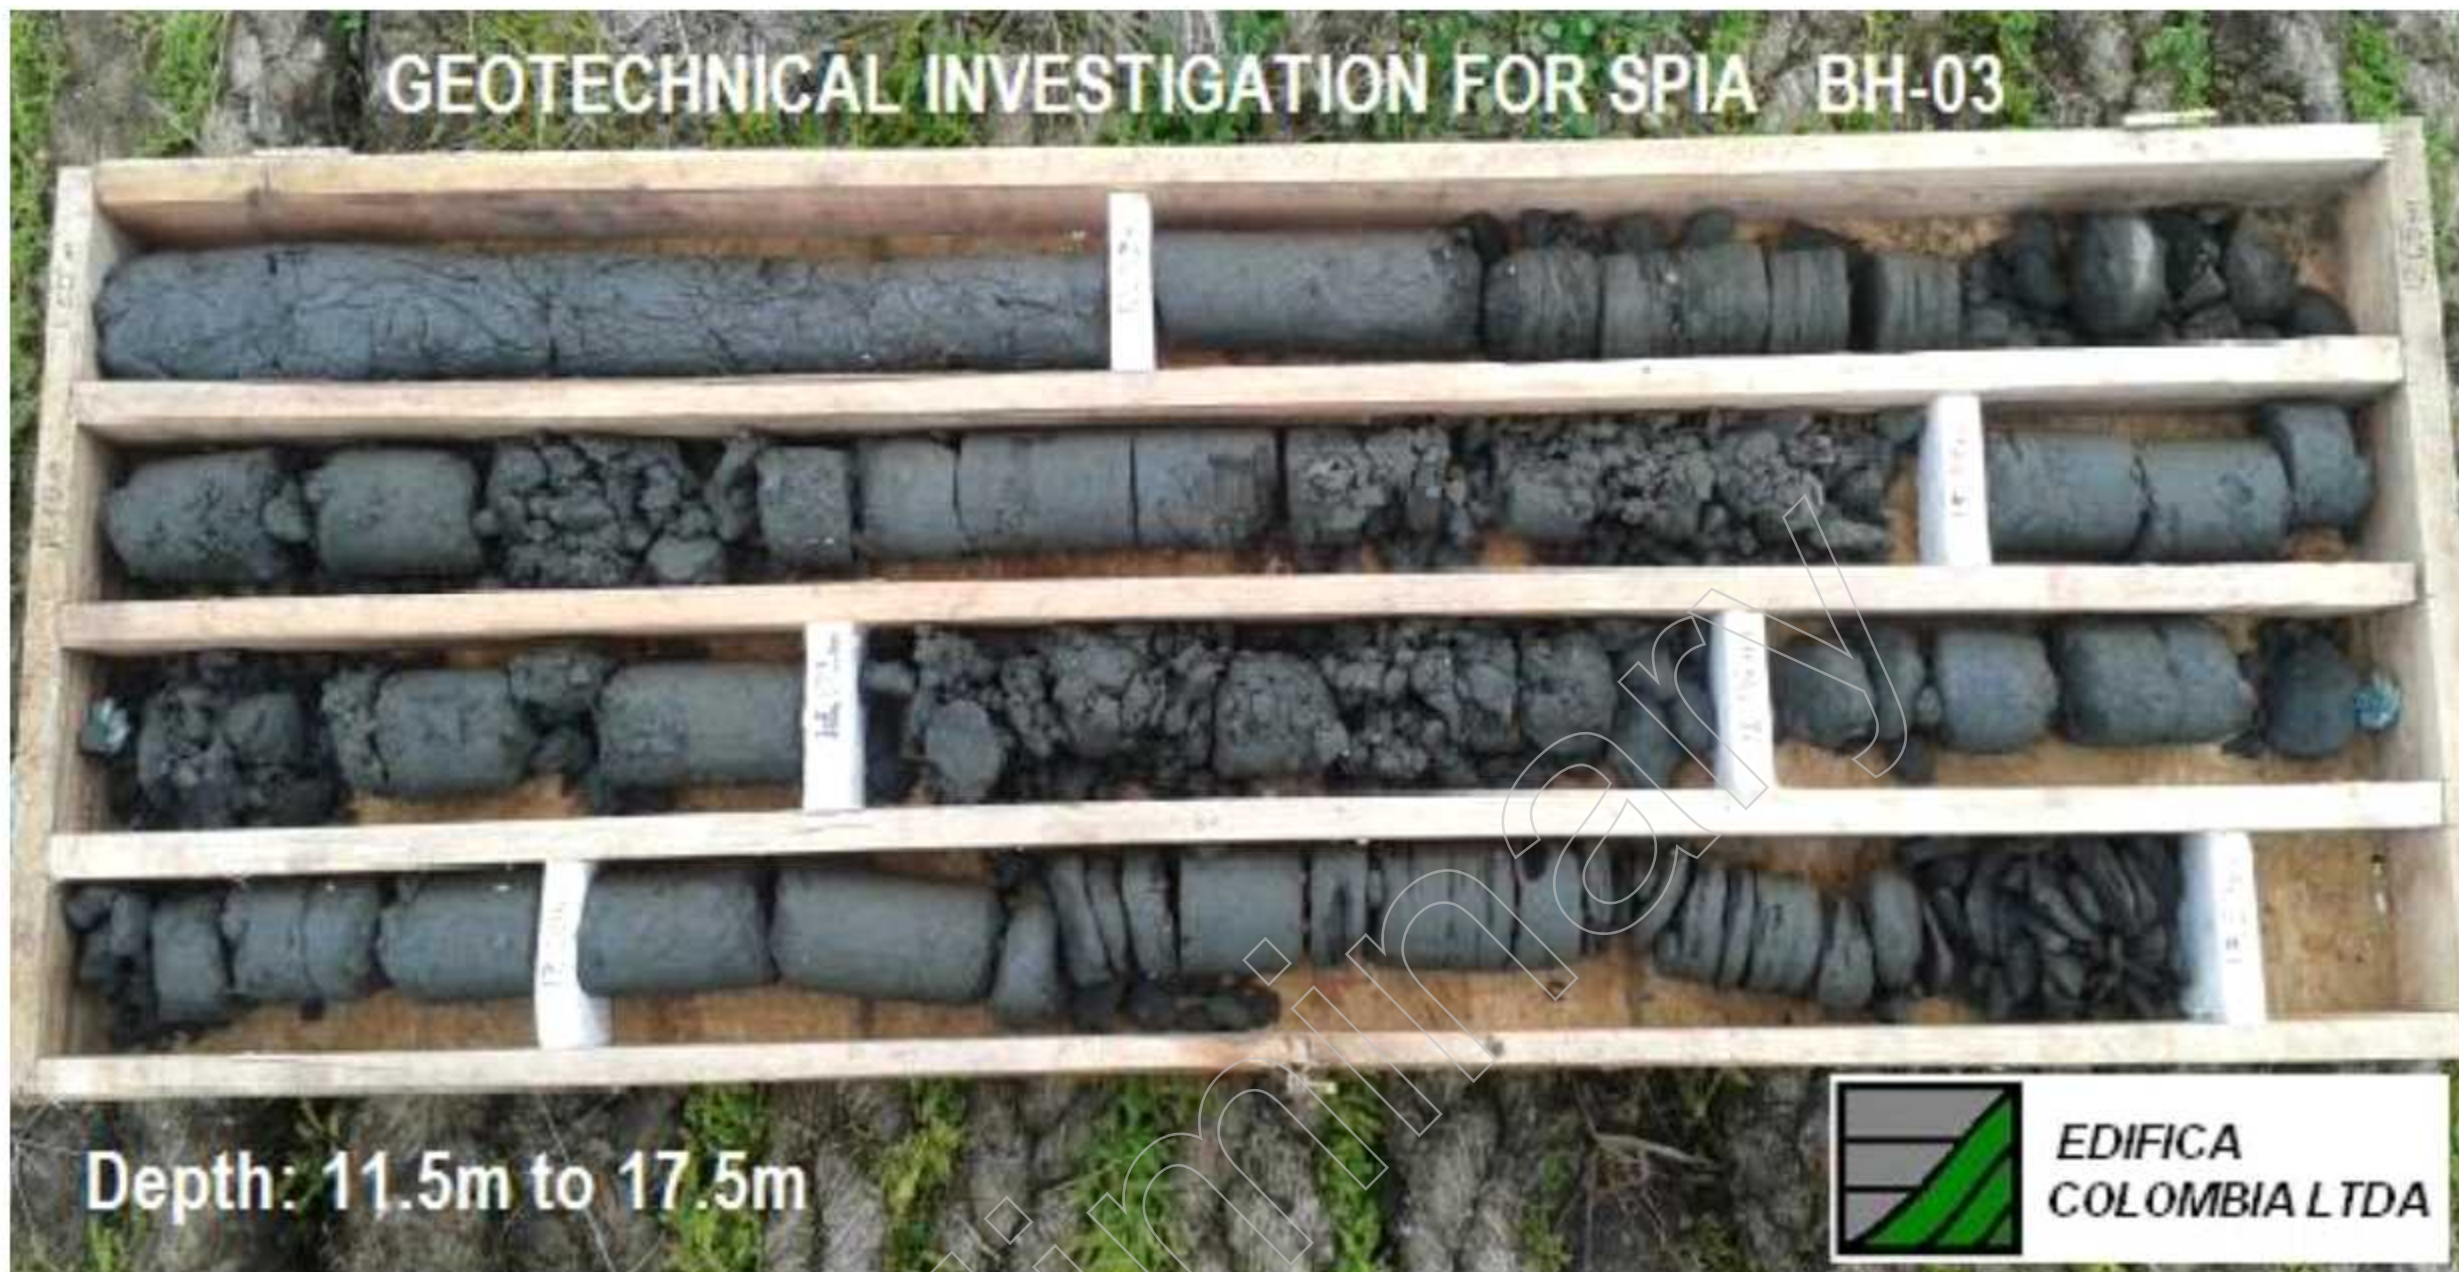
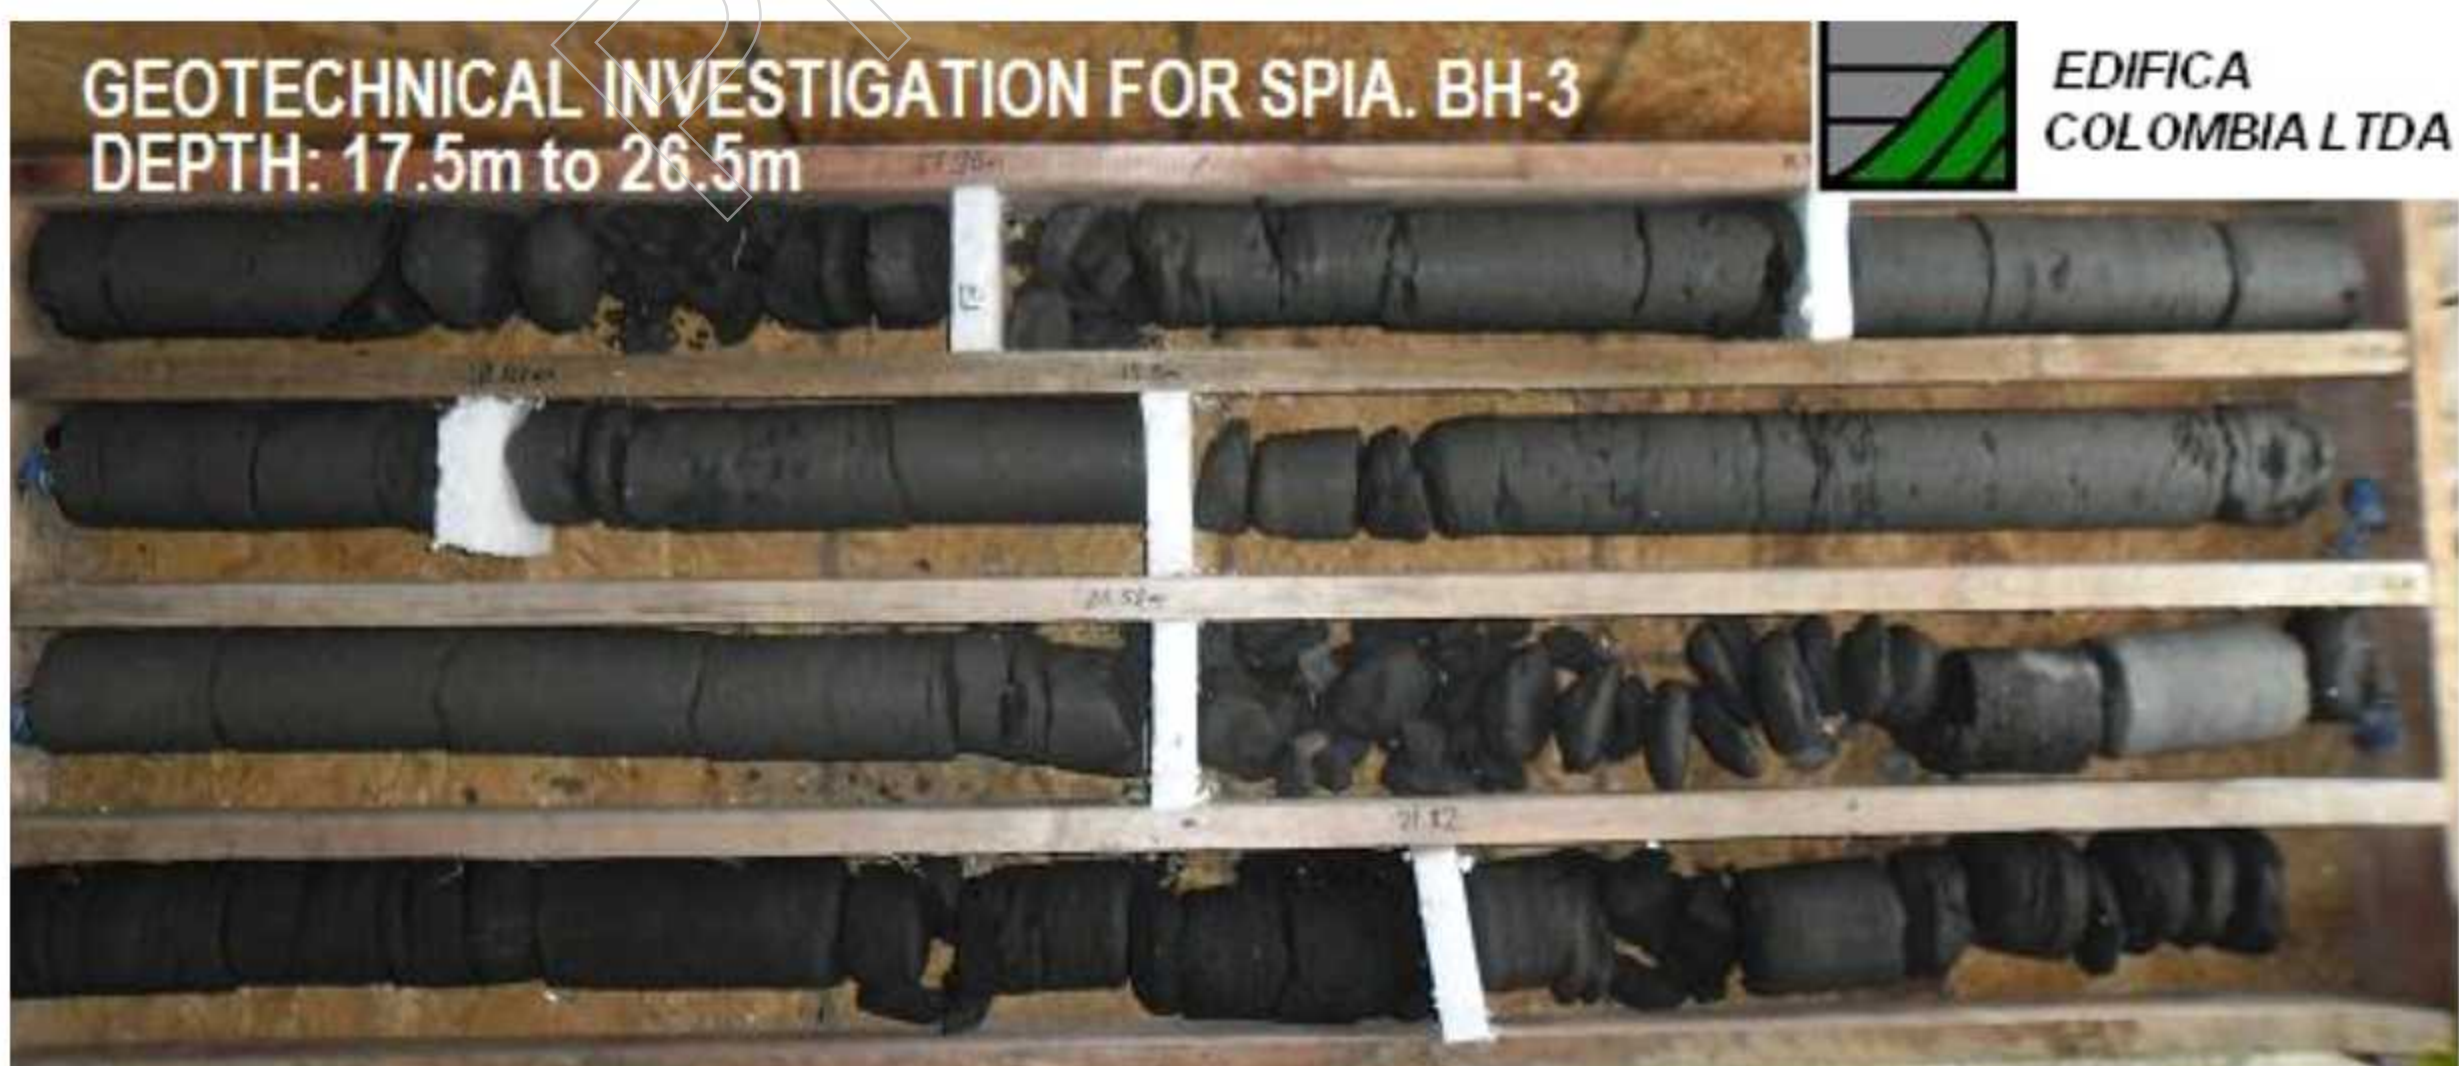
DEPTH (m)	GRAPHIC LOG	MATERIAL DESCRIPTION	SAMPLE TYPE NUMBER	RECOVERY % (RQD)	BLOW COUNTS (N VALUE)	POCKET PEN. (kPa)	DRY UNIT WT. (Mg/m ³)	SPT N VALUE	
								20	40 60 80
		(SP) SAND poorly graded, fine grained, dark gray (Residual)	SPT 8	100	12-50				
12	XXXXXX	Siltstone, dark gray, with sand. (horizontal bedding), friable, highly fractured							
14	XXXXXX		RC 9	43 (6)					
16	XXXXXX	Siltstone, dark gray, with sealshells. (horizontal bedding), friable, highly fractured	RC 10	100 (21)					
18	XXXXXX	Siltstone, dark gray, (horizontal bedding)							
20	XXXXXX		RC 11	91 (63)					
	XXXXXX	Siltstone, dark gray, dark gray, highly fractured
