# TEST PIT NUMBER TP-33

CLIENT SPIA - SOCIEDAD PUERTO INDUSTRIAL AGUADULCE PROJECT NAME PUERTO AGUADULCE  
 PROJECT NUMBER 13016 PROJECT LOCATION AGUADULCE, BUENAVENTURA, COLOMBIA  
 DATE STARTED 23/5/13 COMPLETED 23/5/13 GROUND ELEVATION \_\_\_\_\_ TEST PIT SIZE \_\_\_\_\_  
 EXCAVATION CONTRACTOR Edifica Colombia Ltda GROUND WATER LEVELS:  
 EXCAVATION METHOD Backhoe AT TIME OF EXCAVATION ---  
 LOGGED BY Juan Carlos Vergara CHECKED BY Luis F Vesga AT END OF EXCAVATION ---  
 NOTES \_\_\_\_\_ AFTER EXCAVATION ---

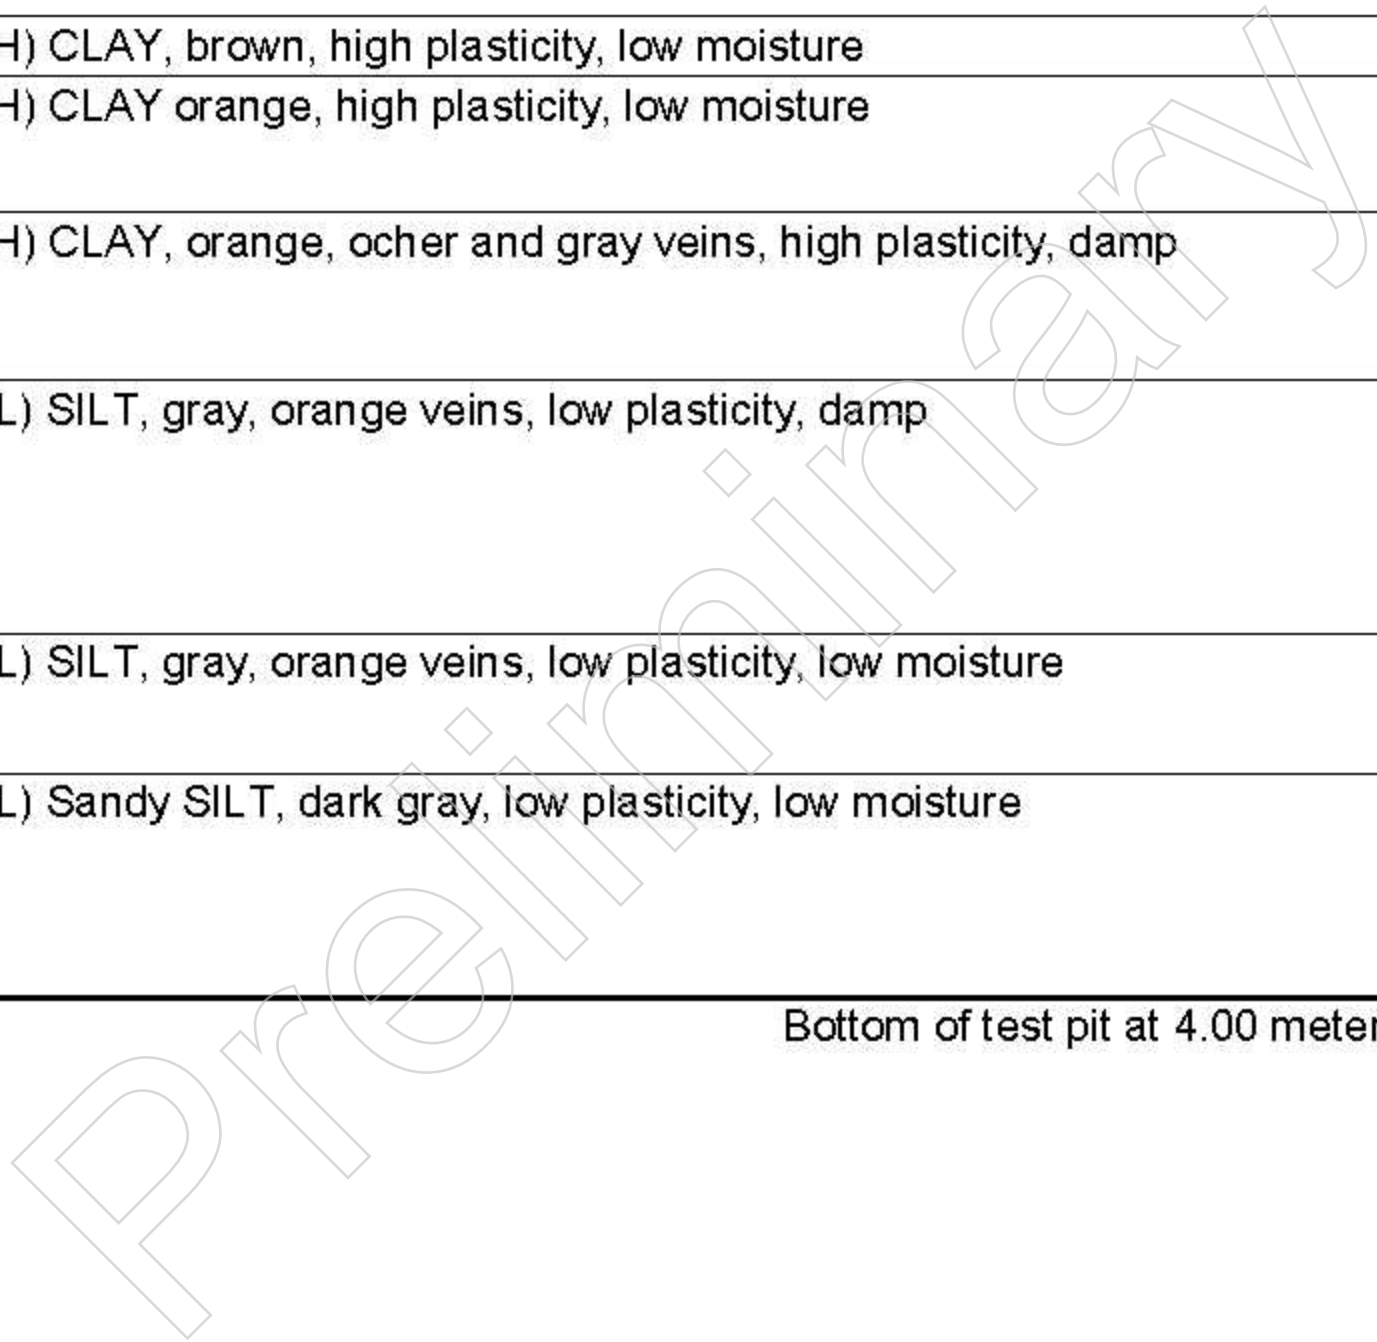
DEPTH (m)	SAMPLE TYPE NUMBER	U.S.C.S.	GRAPHIC LOG	MATERIAL DESCRIPTION		
2		CH		0.20 (CH) CLAY, brown, roots presence, high plasticity, damp		
		CH		0.50 (CH) CLAY, ocher, gray and orange veins, high plasticity, damp		
		CH		0.70 (CH) CLAY, brown, high plasticity, low moisture		
		CH		(CH) CLAY orange, high plasticity, low moisture		
		CH		1.20 (CH) CLAY, orange, ocher and gray veins, high plasticity, damp		
		CH		1.80 (ML) SILT, gray, orange veins, low plasticity, damp		
		4		ML		2.70 (ML) SILT, gray, orange veins, low plasticity, low moisture
				ML		3.20 (ML) Sandy SILT, dark gray, low plasticity, low moisture
ML	4.00

Bottom of test pit at 4.00 meters.
